LAMPIRAN

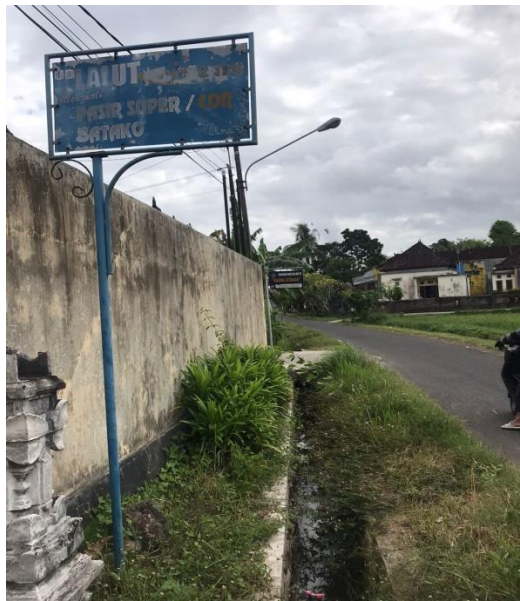
Gambar Saluran Eksisting Jl Nusa Indah I Kiri

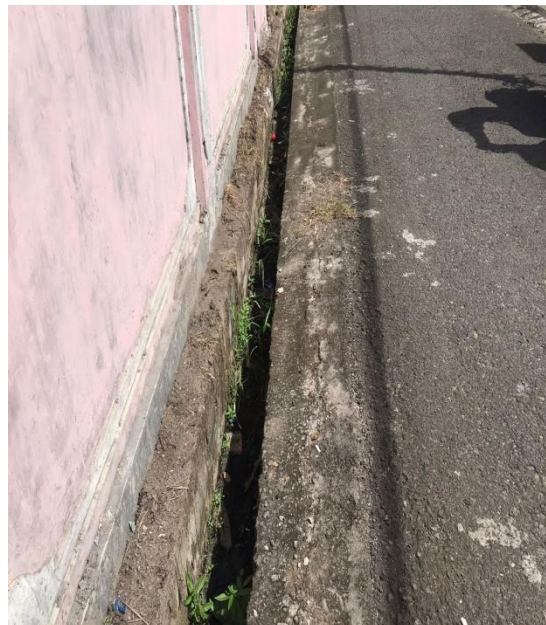
Gambar Saluran Eksisting Nusa Indah I Kiri

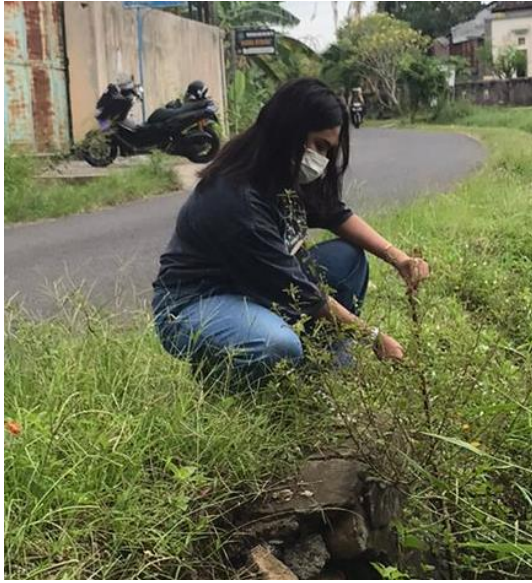
Gambar Pengukuran Dimensi saluran eksisting Jl. Cempaka Kanan

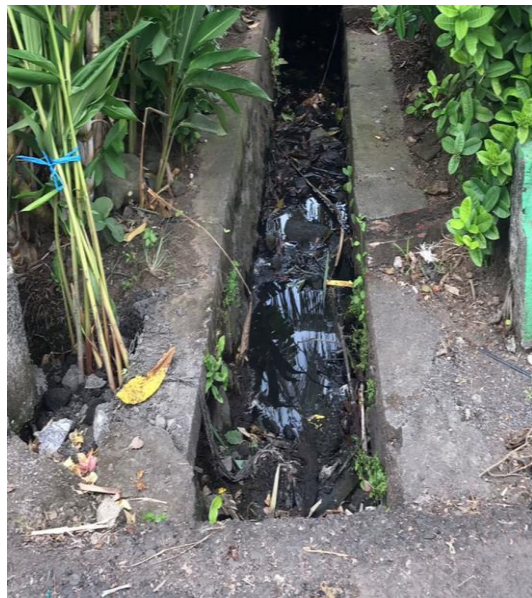
Gambar Saluran Eksisting Jl. Nusa Indah V Kiri
